Manhole Inspection Summary

Manhole # S11MM_018MH

Insp Date: **1/21/09 10:01 AM**

Location Address: **2317 ELLAMONT ST**

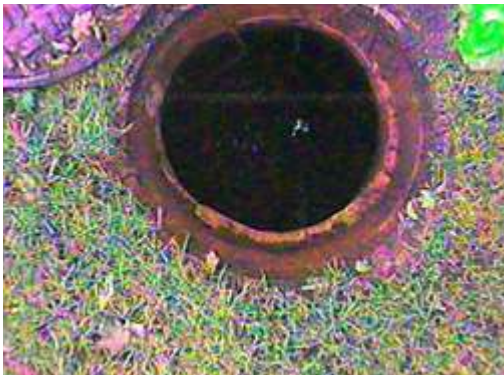
Offset: **3** (in.)

FRAME OFFSET

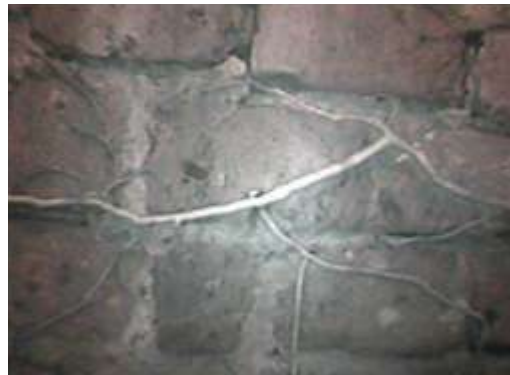
Defect 1

Condition: ☐ Sound ☐ Cracked ☒ **Root Intrusion** ☐ Loose Brick ☐ Deteriorated

Infiltration: ☐ None ☐ Joint ☐ Cracks ☐ Mortar ☒ **Roots** ☐ Wall

ROOTS- FINE BARREL

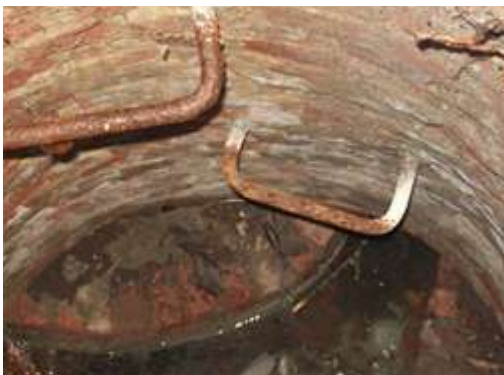
Defect 2

Count: **2** Missing: **0** ☒ **Corroded**

CORRODED STEPS

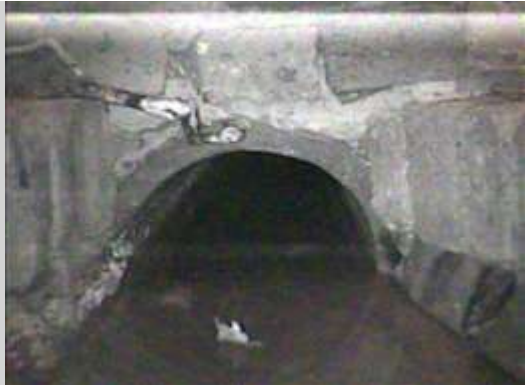
12 O'Clock Outflow

8 in. Circular Gravity Sewer
Pipe Out @ 12 O'Clock

Invert Depth: **6.53** (ft.) Flow Characteristics: **Slow**

Infiltration: **None** Pipe Seal Cond: **Sound**

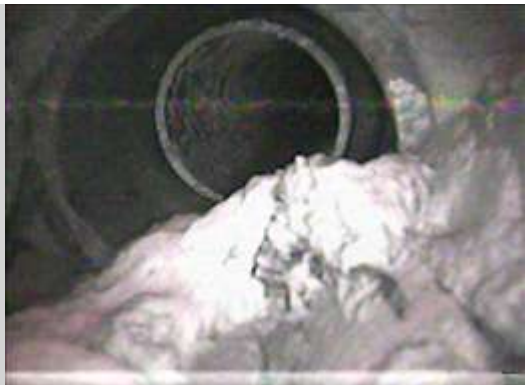
6 O'Clock Inflow

6 in. Circular Gravity Sewer
Pipe In @ 6 O'Clock

Invert Depth: **5.94** (ft.) Flow Characteristics: **Slow**

Infiltration: **None** Pipe Seal Cond: **Sound**

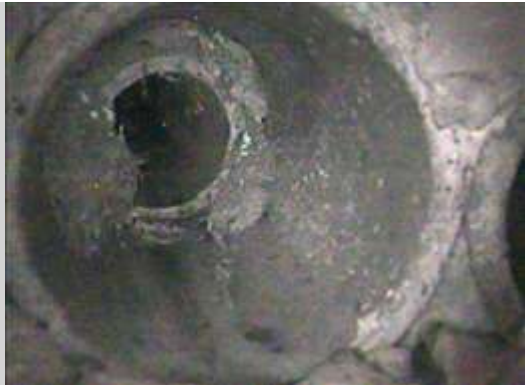
7 O'Clock Inflow

6 in. Circular Gravity Sewer

Pipe In @ 7 O'Clock

Invert Depth: **5.94** (ft.) Flow Characteristics: **Slow**

Infiltration: **None**

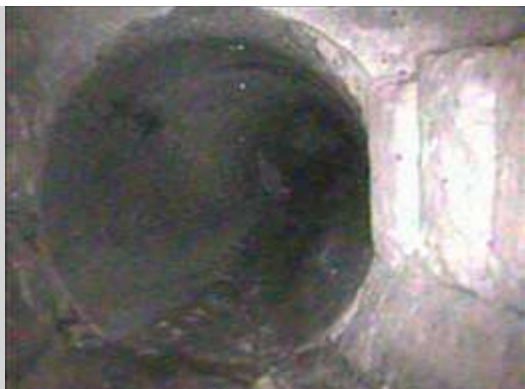
9 O'Clock Inflow

8 in. Circular Gravity Sewer

Pipe In @ 9 O'Clock

Invert Depth: **6.50** (ft.) Flow Characteristics: **Slow**

Infiltration: **None**
